Reference: **Rockville Former Manufactured Gas Plant Site**
REM ID: 13641/SEH ID: 1075
Significant Environmental Hazard Status Update Form: Soil

Significant Environmental Hazard Status Update Form: Soil [Connecticut General Statutes (CGS) Section 22a-6u]

Name of Site: Rockville Former MGP Site(REM ID13641/SEH ID1075)

Rockville Former MGP
Significant Environmental Hazard Status Update Form: Soil
Date Photographed: May 12, 2023
Address: 13 Maple Street, Rockville, Vernon, Connecticut

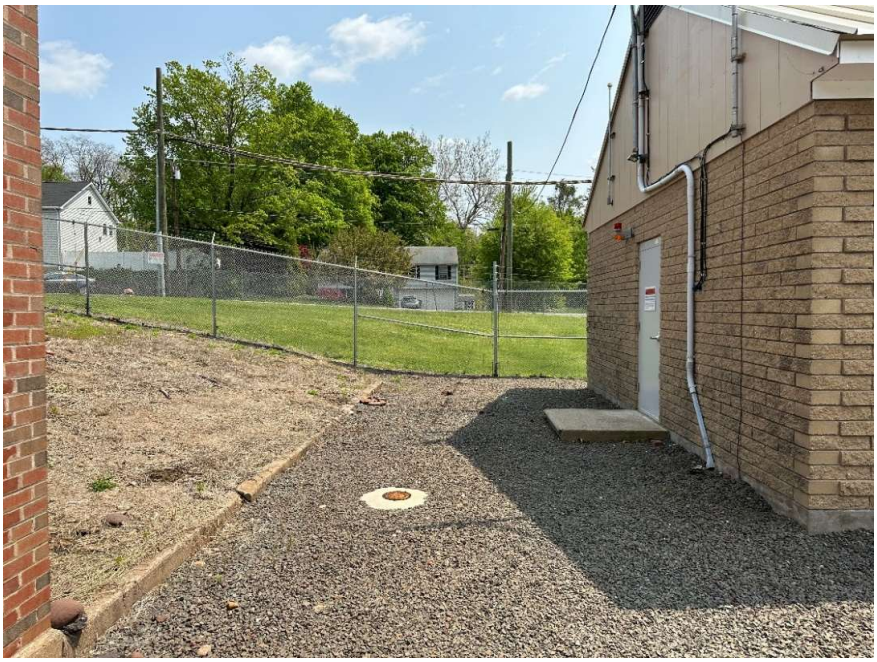
Photo No. 3 – SEH condition area (SB-76 and SB-76A) within the inner substation (facing east).
