Electronic Transmittal Form for DEEP Remediation and LUST Secure File Transfer (SFT)

Reference: **Rockville Former Manufactured Gas Plant Site**
REM ID: 12390/SEH ID: 13641
Significant Environmental Hazard Status Update Form: Soil

Significant Environmental Hazard Status Update Form: Soil [Connecticut General Statutes (CGS) Section 22a-6u]

Name of Site: Rockville Former MGP Site(REM ID12390/SEH ID13641)

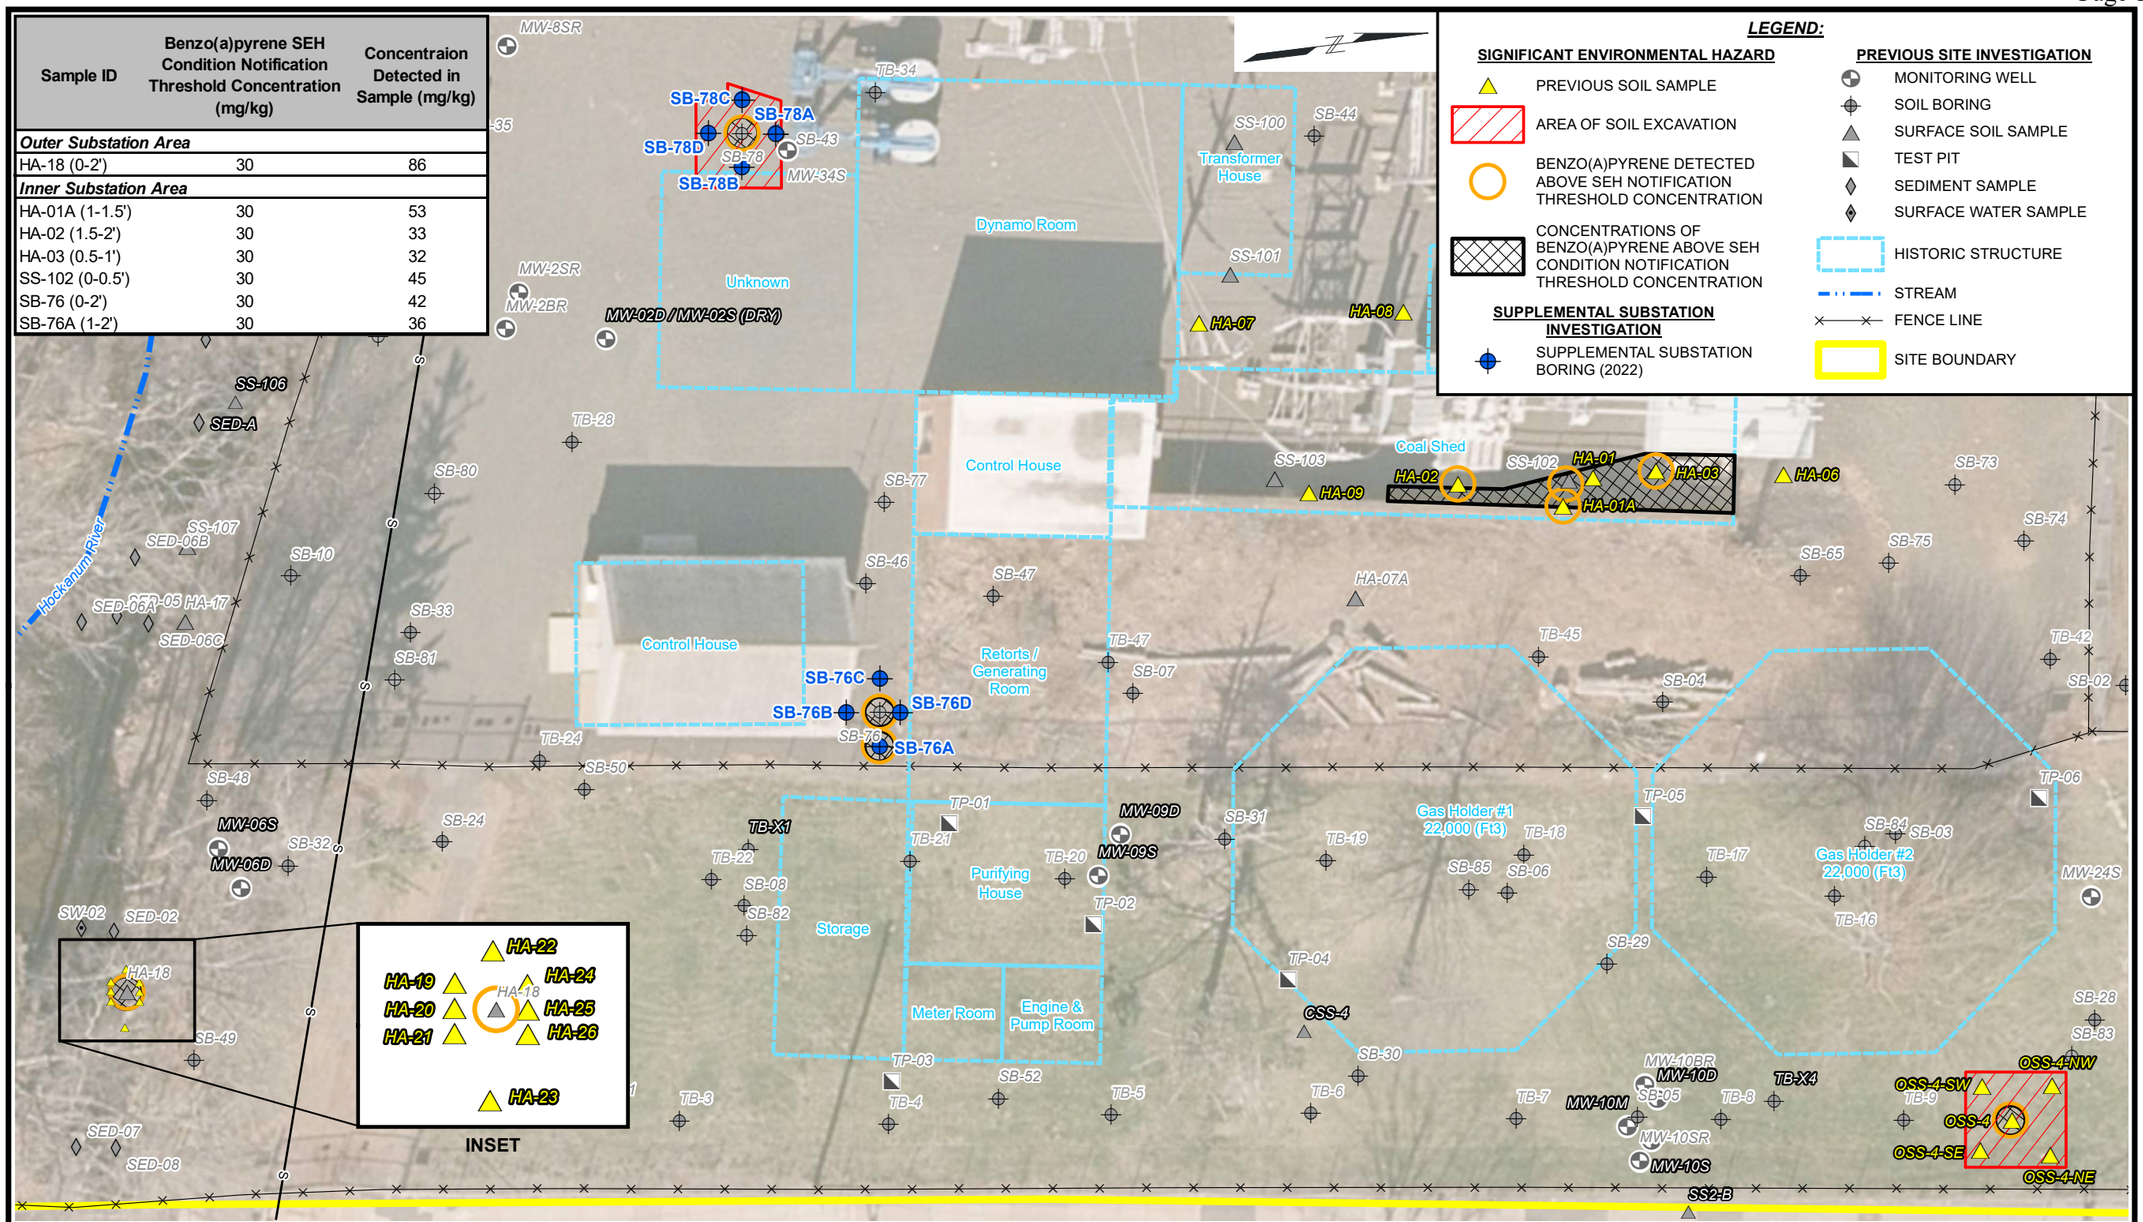
Project 2200138 | May 2022 | Fig. 2

Sample ID	Benzo(a)pyrene SEH Condition Notification Threshold Concentration (mg/kg)	Concentraion Detected in Sample (mg/kg)
Outer Substation Area		
HA-18 (0-2')	30	86
Inner Substation Area		
HA-01A (1-1.5')	30	53
HA-02 (1.5-2')	30	33
HA-03 (0.5-1')	30	32
SS-102 (0-0.5')	30	45
SB-76 (0-2')	30	42
SB-76A (1-2')	30	36

SIGNIFICANT ENVIRONMENTAL HAZARD (SEH) INVESTIGATION AND EXCAVATION LOCATIONS
