February 2025

Eversource Energy

Final Remedial Action Report

27 Parsons Lane
Durham, Connecticut
Eversource Spill Number CWC-18-00543

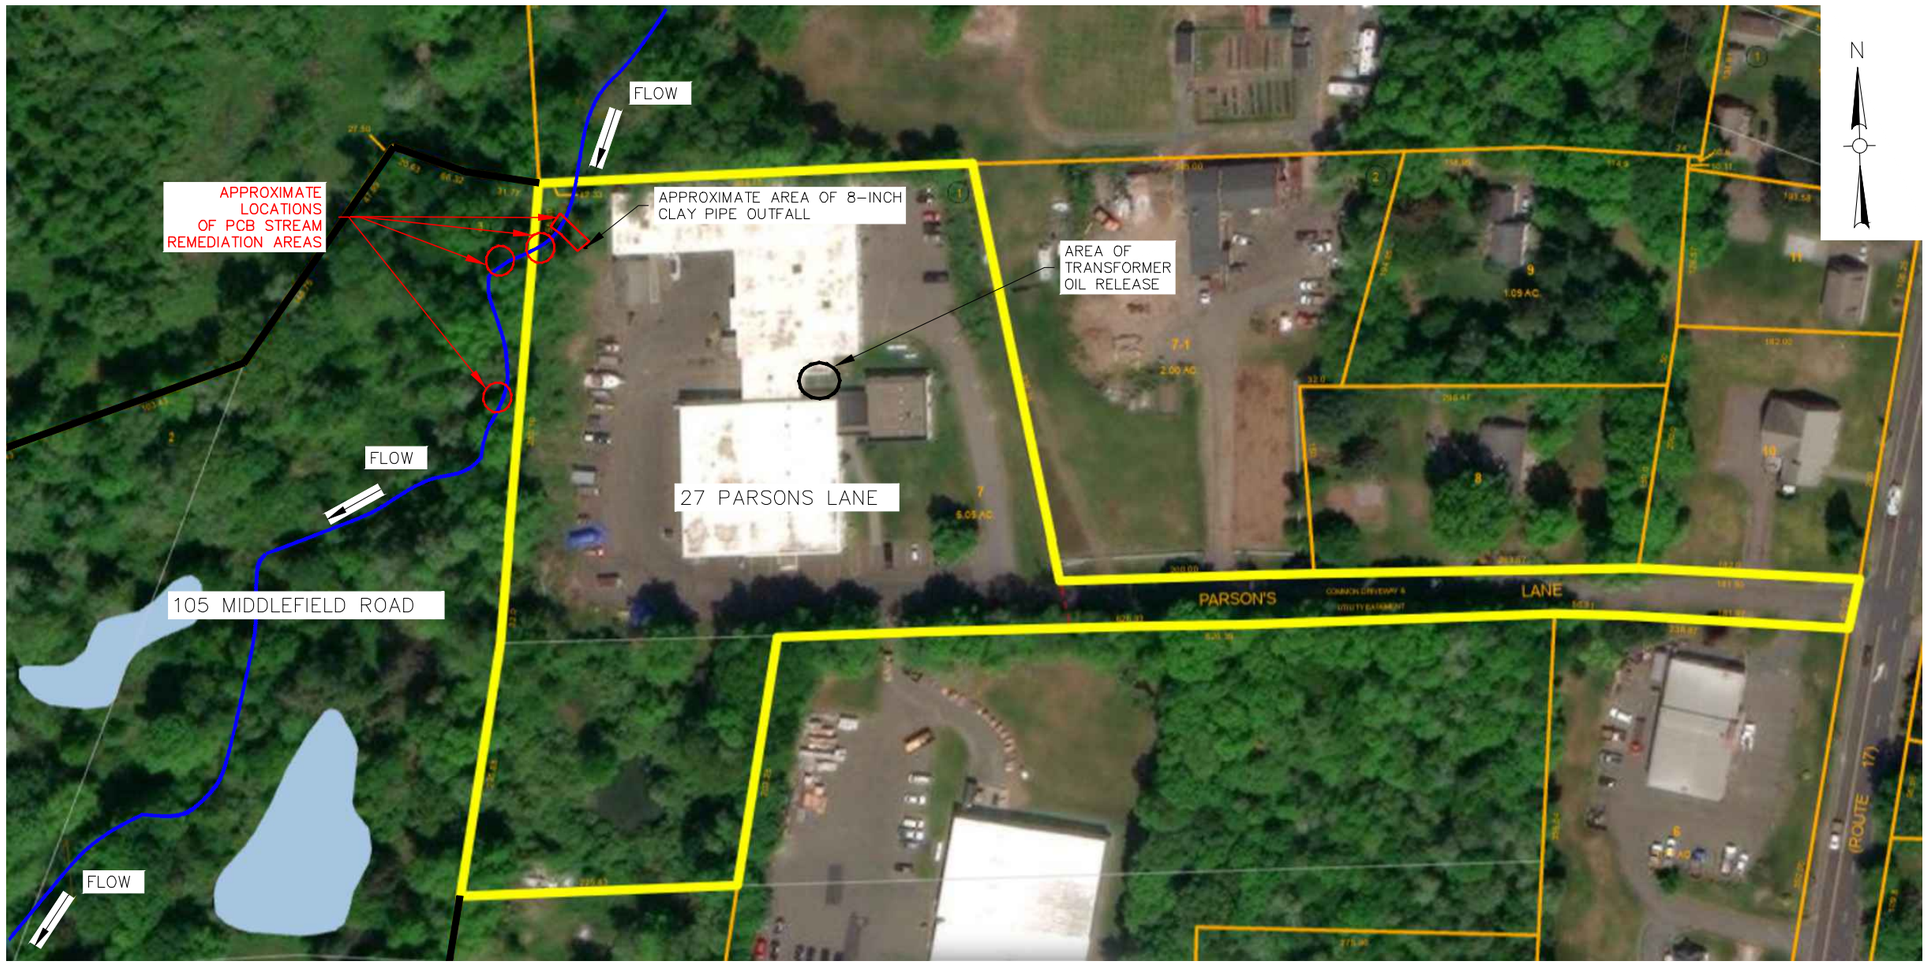
FIGURE 2

The initial MODF release at 27 Parsons Lane involved a broken utility pole supporting a bank of three customer-owned pole-mounted transformers that fell onto the roof of the industrial/commercial building centrally located on the property (see **Figure 2 – Existing Conditions Plan**). The impact caused a puncture through the roof of the building, and one transformer released most of its oil content into a restroom/utility room inside the building. Three floor drains inside the bathroom/utility room were affected, two drains emptied into a nearby (outdoor) catch basin in a grass lawn "courtyard area" that discharged via an outlet pipe to a discharge channel connected to an intermittent stream on the northwestern corner of the parcel, and one drain discharged into the building's active septic system. The property owner's contractor relocated the three transformers onto the ground outside the building. The primary bushings from the two undamaged transformers were subsequently removed, purportedly by vandals, causing these transformers to release their oil contents onto a grass lawn "courtyard area" and into the same courtyard catch basin that discharged to the stream on the northwestern corner of the parcel. The total quantity of oil released from this incident was reported as approximately 100 gallons with approximately 33 gallons (one transformer) having been released inside the building and approximately 67 gallons (two transformers) having been released outside in the courtyard area. Notification of the releases to the CT DEEP was completed on October 19, 2018. Analysis of the oil collected from the transformers revealed total PCB concentrations exceeding 50 milligrams per kilogram (mg/kg) subsequently making the release regulated by the Environmental Protection Agency (EPA) under the Toxic Substances Control Act (TSCA).

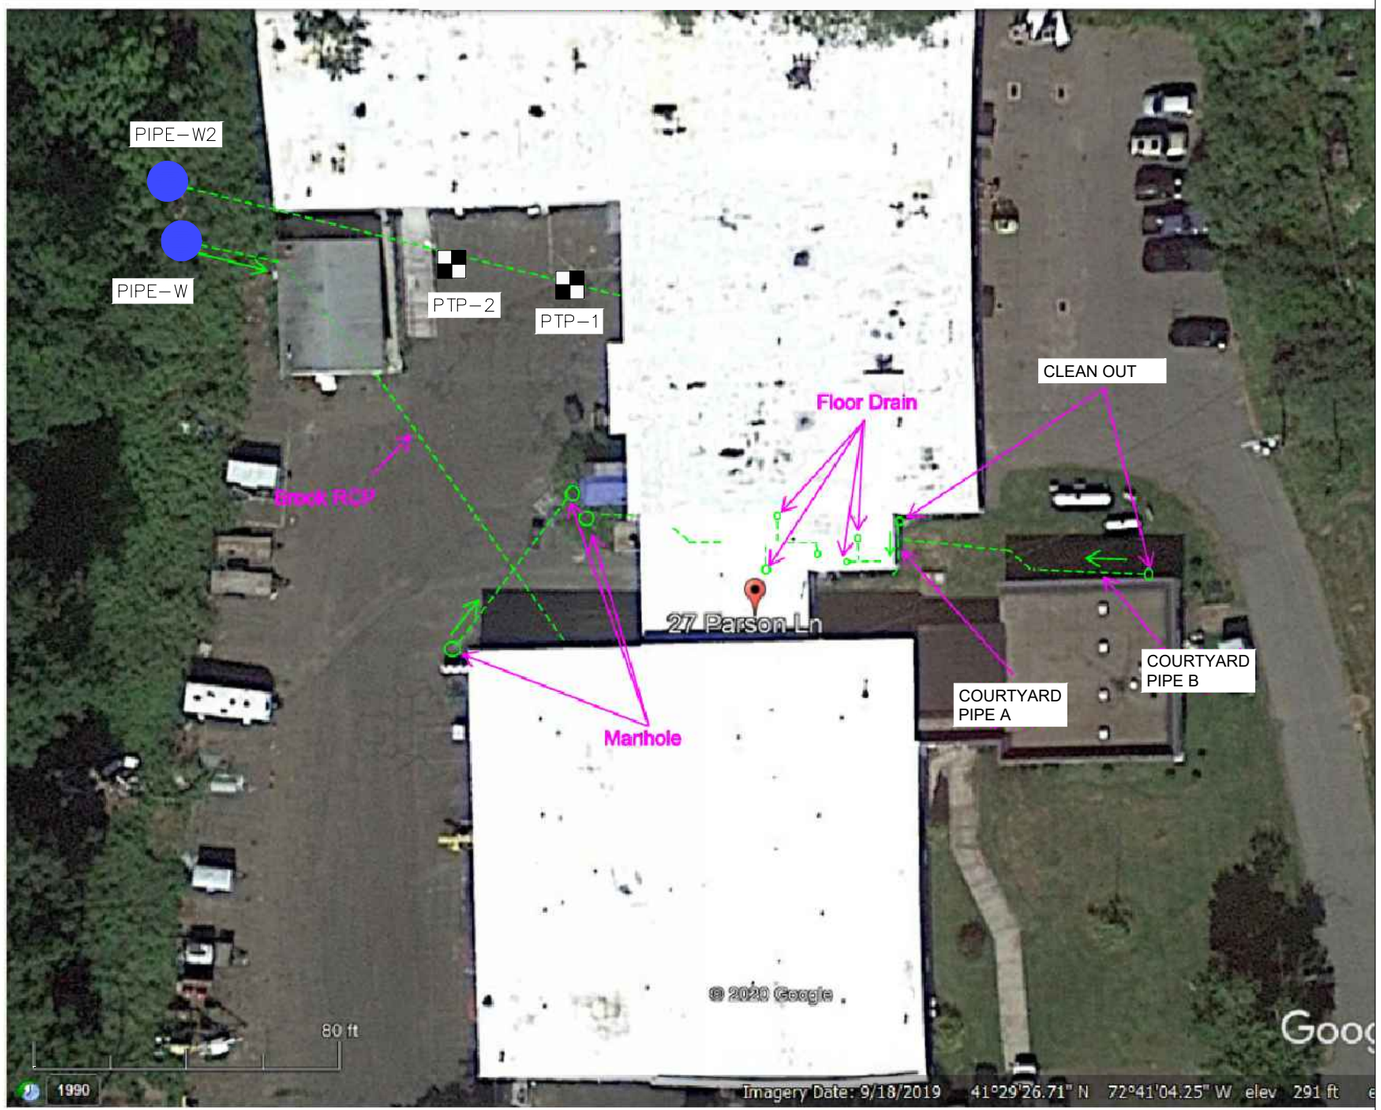
the piping was cut open for sampling. Two samples from the inside bottom surfaces of the clay pipe substrate (designated PTP-1 and PTP-2), one from each test pit, were collected and tested for PCBs. After the samples were collected, the sections of the 8-in. clay pipe were repaired by connecting 8-in. sections of PVC pipe with tightened flexible couplings (Ferncos®).

Two water samples of effluent observed discharging out the 8-in. clay pipe (PIPE-W2) and a nearby 8-in. RCP (PIPE-W) were also collected and tested for PCBs during these activities (Figure 3). Effluent and substrate samples from the 8-in. clay pipe were collected and tested because this pipe was previously affected by the MODF release, and we were assessing for absence/presence of PCB impacts after the spill cleanup actions completed in October and November 2018. Effluent from the 8-in. RCP was collected and tested to provide an additional line of evidence this outlet pipe was not impacted by the MODF release.

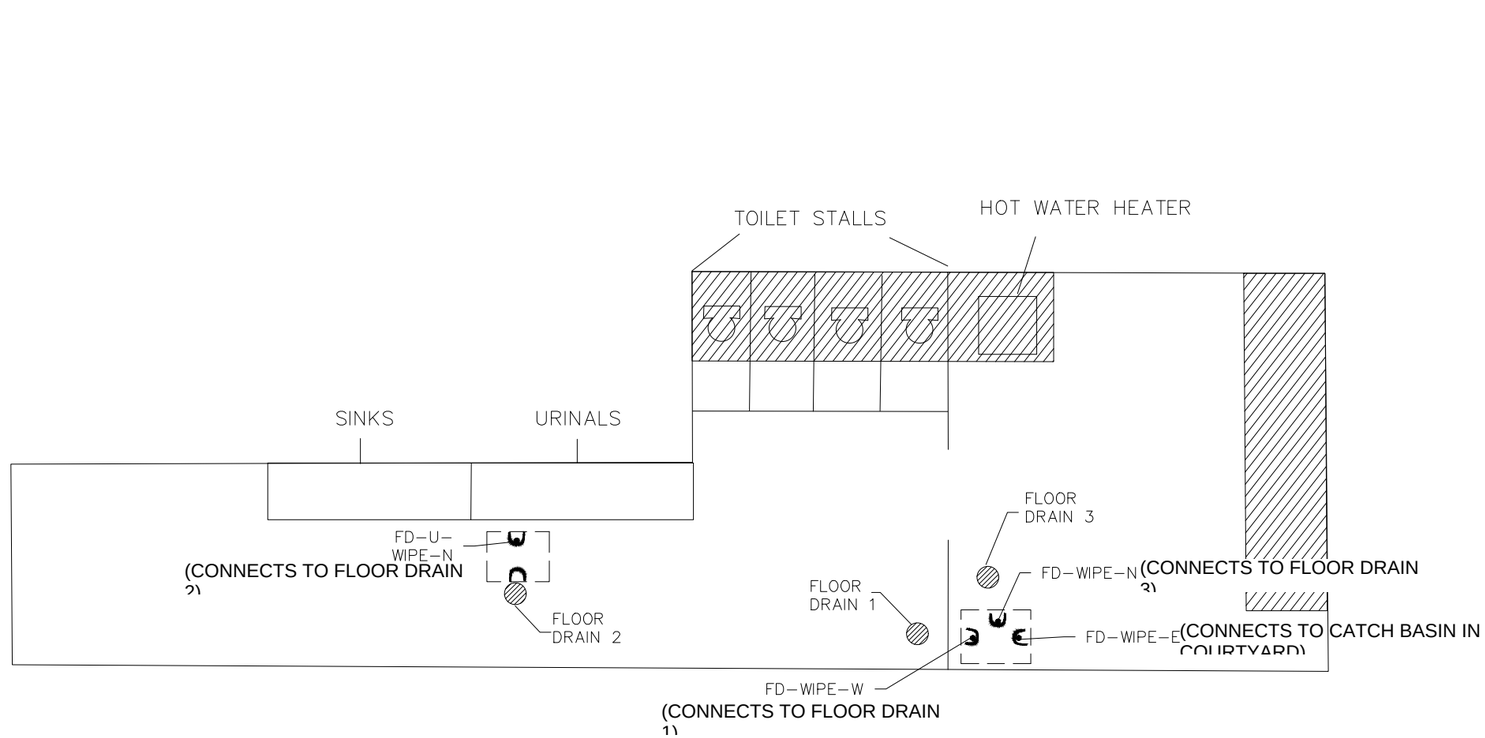
FIGURE 4

On October 5, 2023, four PCB wipe samples were collected as specified in 40 CFR 761.123 from the interior surface of three floor drains located in the bathroom/utility room area of the building affected by the MODF release. The concrete floor and associated drainpipes were saw cut (under negative pressure containment to control dust emissions) in two areas to permit discrete wipe sampling of all three floor drainpipes and the drainpipe that emptied into the previously removed courtyard catch basin. The wipe samples were collected to demonstrate the effectiveness of the spill response actions performed in 2018 and evaluate if additional remedial actions were needed for the affected floor drains. The wipe samples were labeled as follows: FD-U-WIPE-N was from floor drain #2, FD-WIPE-W was from floor drain #1, FD-WIPE-N was from floor drain #3 and FD-WIPE-E was from the discharge pipe that previously drained into the courtyard catch basin (Figure 4).

Lastly, Weston & Sampson would like to acknowledge the floor drain locations and ID's as shown on Figure 6 in the IRAR are inaccurate. Figure 4 in this report correctly portrays the floor drain locations and ID's.

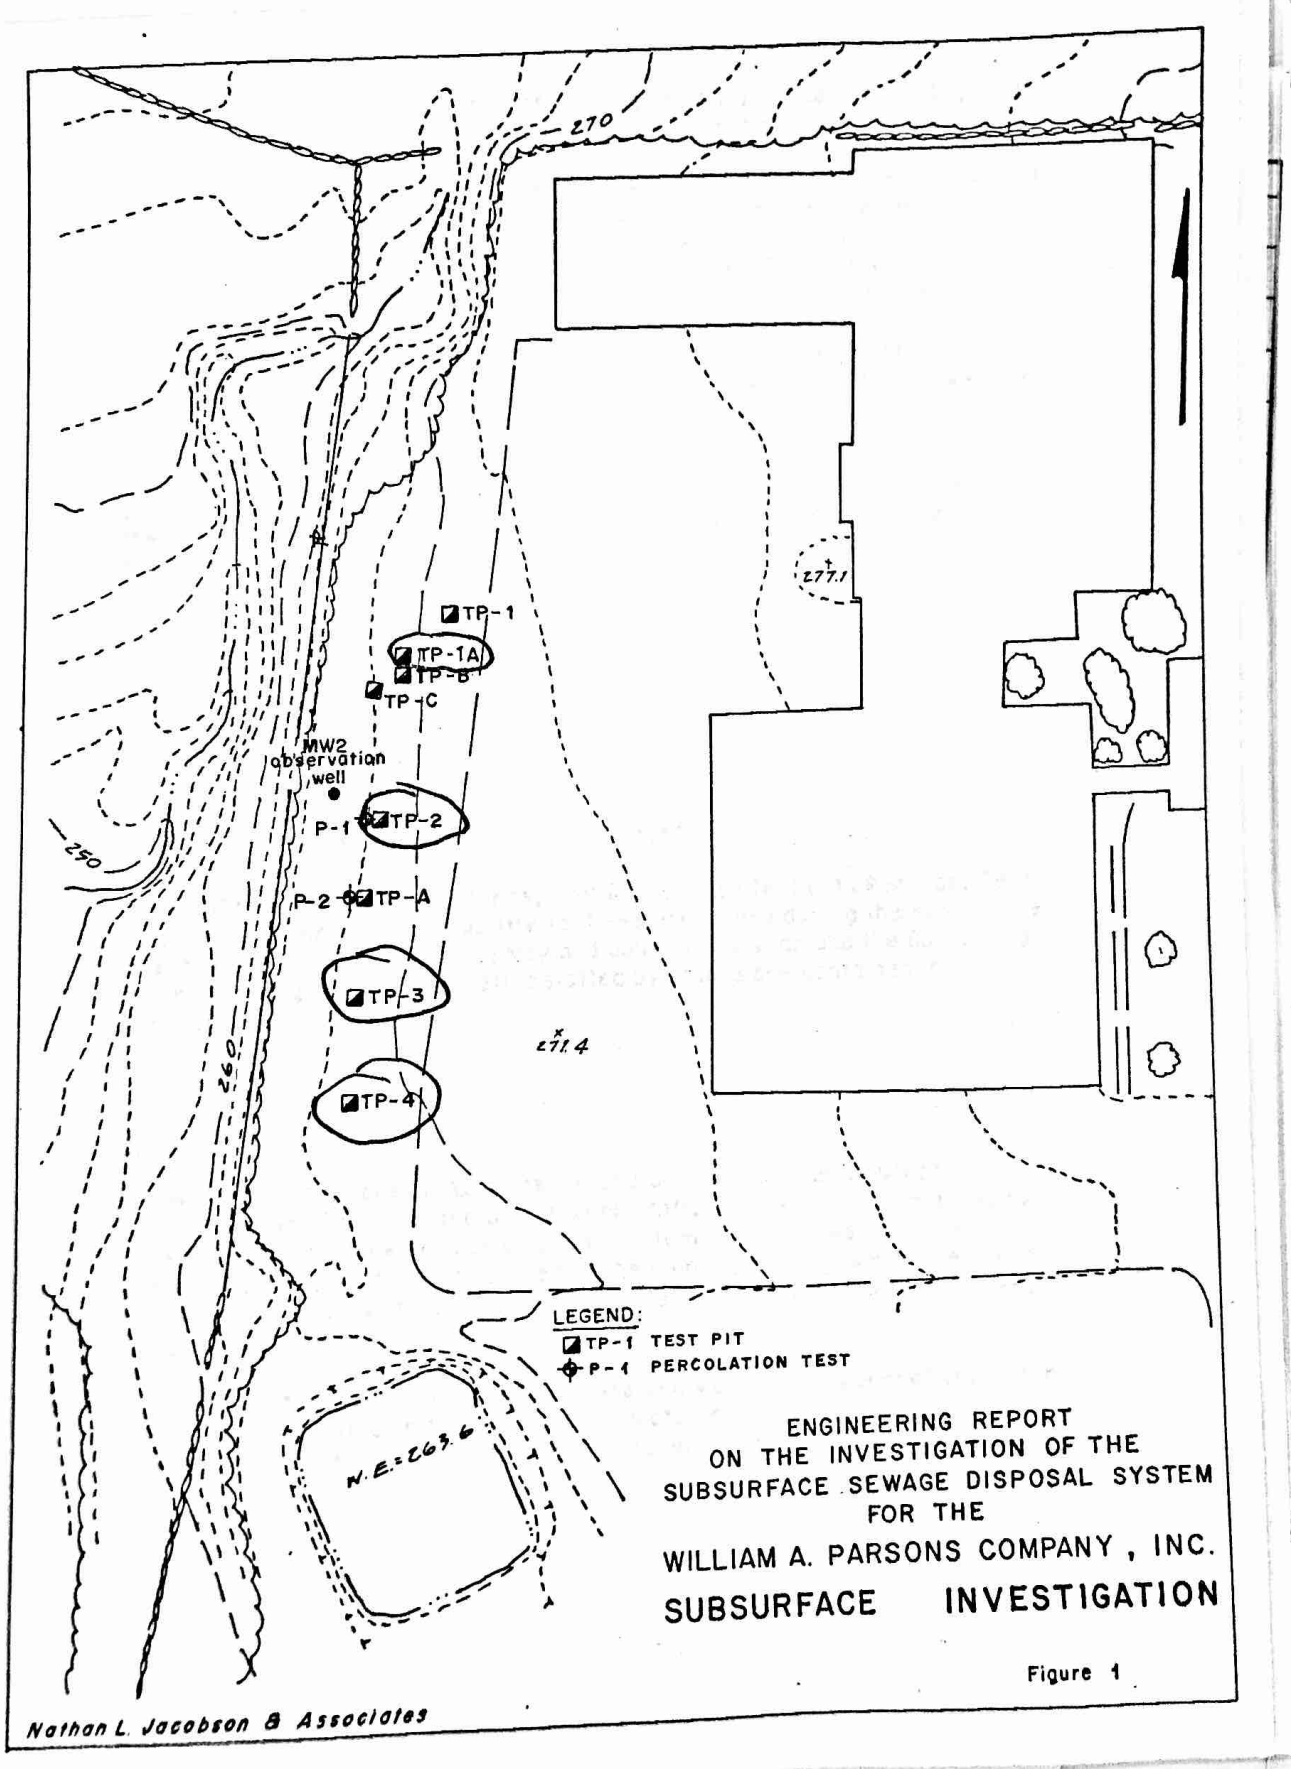
In May of this year, subsurface investigations were conducted in part to locate and determine the condition of the existing leaching system. Using a hydraulic backhoe, excavations began with Test Pit 1 (see Figure 1). Material encountered consisted of a brown fine to coarse sand and gravel with no water or seeps noted in the excavation. After reaching a depth of approximately 48 inches the east wall of the excavation cracked and then gave way with an instantaneous release of sewage effluent flooding the excavation. It was apparent that the test pit was excavated immediately adjacent to the existing leaching field and that an extensive, almost impermeable, crust had developed at the stone/soil interface of the existing leaching field. This condition would explain earlier observations noted by plant representatives during pump out of the septic tanks, and for the absence of any water or

As previously noted, subsurface investigations were conducted in May of this year in part to locate and determine the condition of the existing leaching system, and to document subsurface conditions. The initial investigation included the excavation of the five Test Pits located in the grassed area to the west of the plant between the edge of the parking lot pavement and the top of slope (see Figure 1). With the exception of Test Pit 1, which was backfilled after being flooded, all pits were excavated to depths of 8 to 9 feet below existing ground. In general, the Test Pits revealed a consistent soil profile including a brown topsoil layer to a depth of between 8 and 10 inches underlain by a brown fine to coarse sand and gravel fill material to a depth of 42 to 48 inches. At this point two of the Test Pits contained a layer of brown topsoil/subsoil which appeared to be the original ground prior to the placement of the upper layer of fill material. With the exception of the above noted variation all holes continued with a red brown fine sand to a depth of 6 to 8 feet underlain by a more compact layer of brown fine to coarse sand, some fine to medium gravel with a trace of silt. No ledge was encountered in any of the Test Pits, and with the exception of a seep noted in Test Pit 1A at a depth of 72 inches, no water was found. To gain a general understanding of the ability of existing soil to accept sewage effluent, two Percolation Tests were run at depths of 34 and 78 inches below existing ground. Both tests yielded percolation rates of 5 minutes per inch indicating soils that are suitable for subsurface sewage disposal.

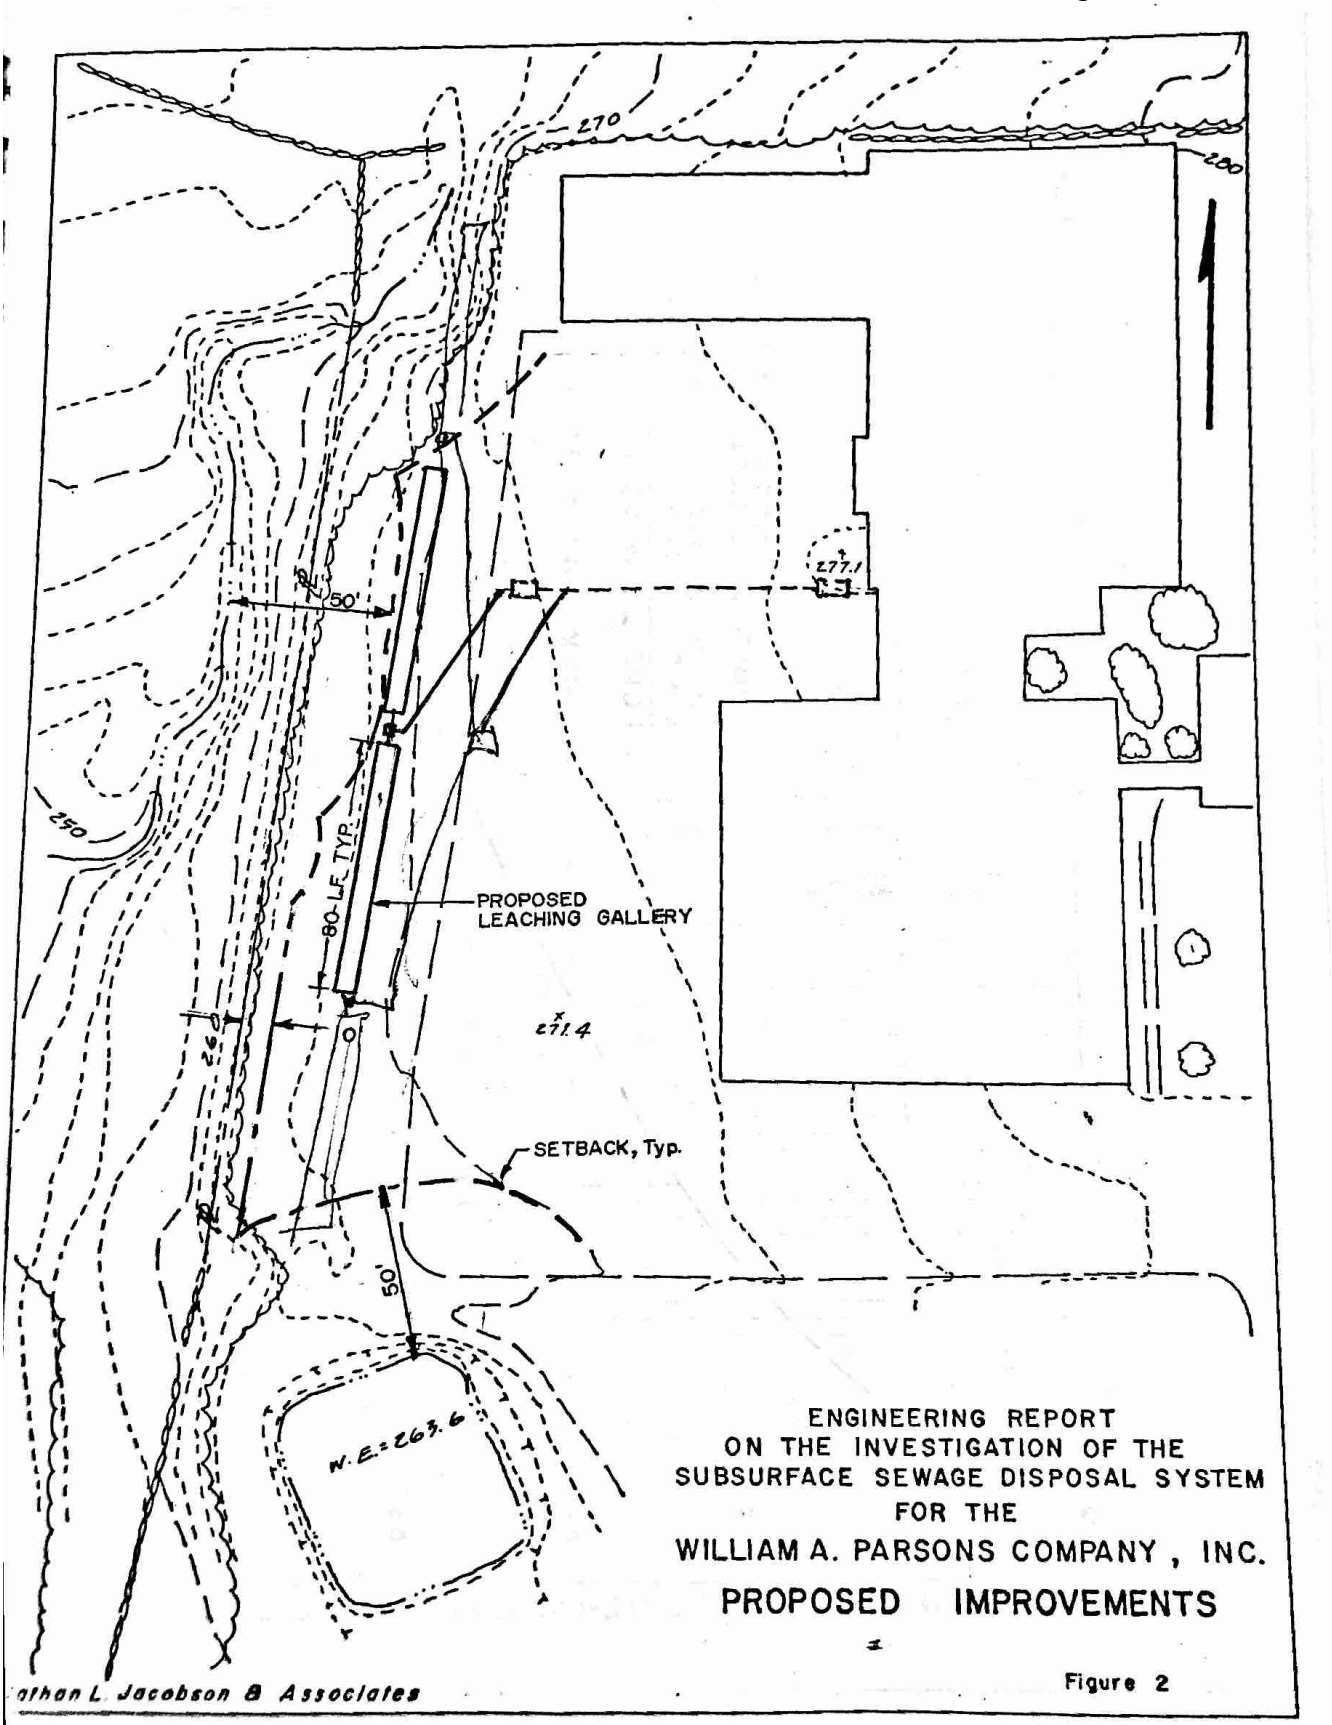
provisions for required setbacks from the existing watercourse, lagoon and property line, the useable area available for locating a proposed replacement system is somewhat limited. Given the limitations with respect to area, and the relatively low water table, the type of system which provide the greatest effective leaching area under these conditions would be galleries. This type of system also has the added benefit of providing a large internal storage volume which provides a buffer for slug flows. Utilizing a percolation rate of 5.1 to 10.0 minutes, the Public Health Code limits the application rate to 1.6 gallons per day per square foot of effective leaching area. Therefore the effective leaching area required is $\frac{1840}{1.6}$ = 1150 square feet - with 8 square feet of effective leaching area per linear foot of gallery, the total length of galleries required is $\frac{1150}{8}$ = 144 LF. To provide good distribution and to meet the Public Health Code limitations regarding the maximum length of galleries (75 ft), two sections of at least 72 LF should be provided. As can be seen from Figure 2, there is sufficient suitable area on site to accommodate this system.

Following the initial investigation of the existing subsurface sewage disposal system and subsurface conditions, it was apparent that a new replacement system would be required and that the grassed area located between the edge of the existing parking lot and top of slope would be a suitable location for the new system. Given the relatively dry conditions which prevailed throughout the spring of 1985, additional soils investigations were conducted by a Certified Soil Scientist during the first week of June. The primary objective of the additional investigation was to obtain undisturbed soil cores which could be transported to the laboratory and saturated prior to running permeability tests. This testing found permeability rates to be in the range of 6.7 to 33.2 feet per day, and provided more reliable data for sizing a new replacement subsurface sewage disposal system.
