Site Name: Former Rockville Manufactured Gas Plant

Annual Report

Date of Document: 5/27/2020

Significant Environmental Hazard Status Update Form: Soil [Connecticut General Statutes (CGS) Section 22a-6u]

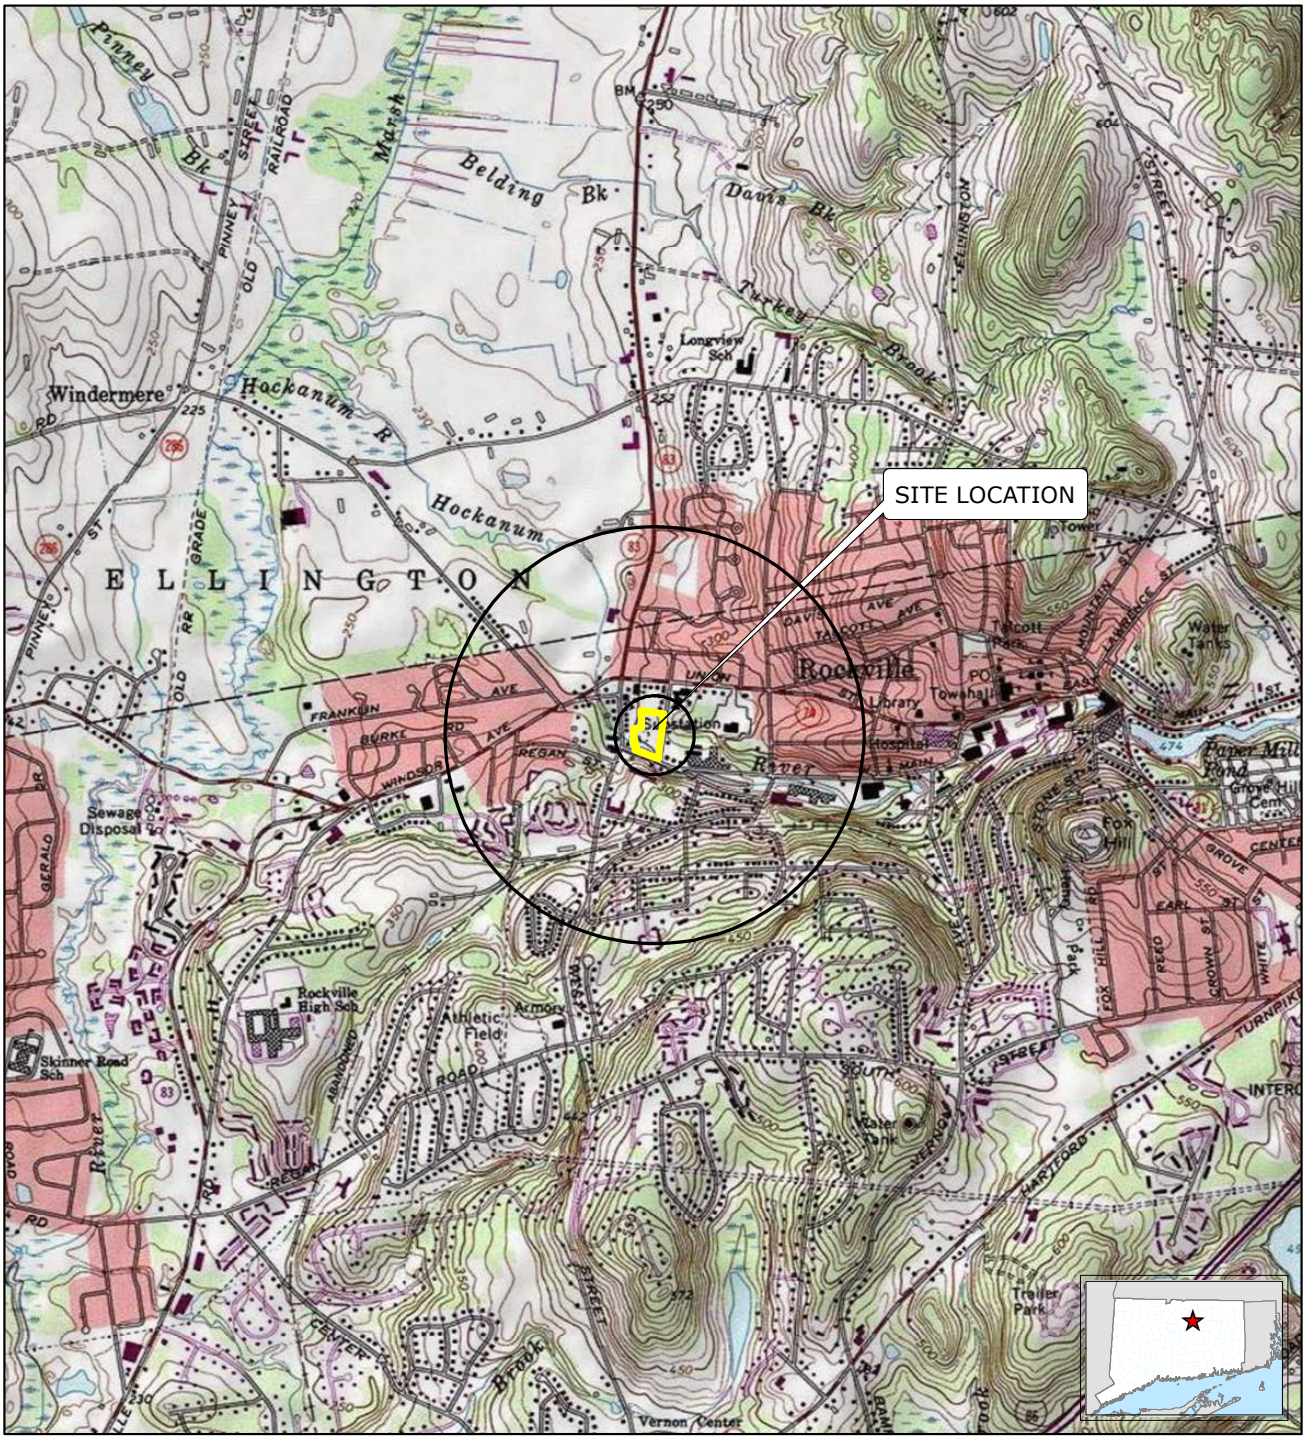
FIGURE 2
SIGNIFICANT ENVIRONMENTAL HAZARD SUMMARY

Sample ID	Benzo(a)pyrene SEH Condition Notifcation Threshold Concentration (mg/kg)	Concentration (mg/kg)
Outer Substation Area		
HA-18 (0-2')	30	86
Inner Substation Area		
HA-01A (1-1.5')	30	53
HA-02 (1.5-2')	30	33
HA-03 (0.5-1')	30	32
SS-102 (0-0.5')	30	45
